# 1990 - CID510160\_TazewellCounty\_CFPF-6

**Funding Opportunity:** 1446-Virginia Community Flood Preparedness Fund - Capacity Building/Planning Grants - CY23 Round 4  
**Funding Opportunity Due Date:** Nov 12, 2023 11:59 PM  
**Program Area:** Virginia Community Flood Preparedness Fund  
**Status:** Under Review  
**Stage:** Final Application

## Hazard Mitigation Plan Update

## Introduction

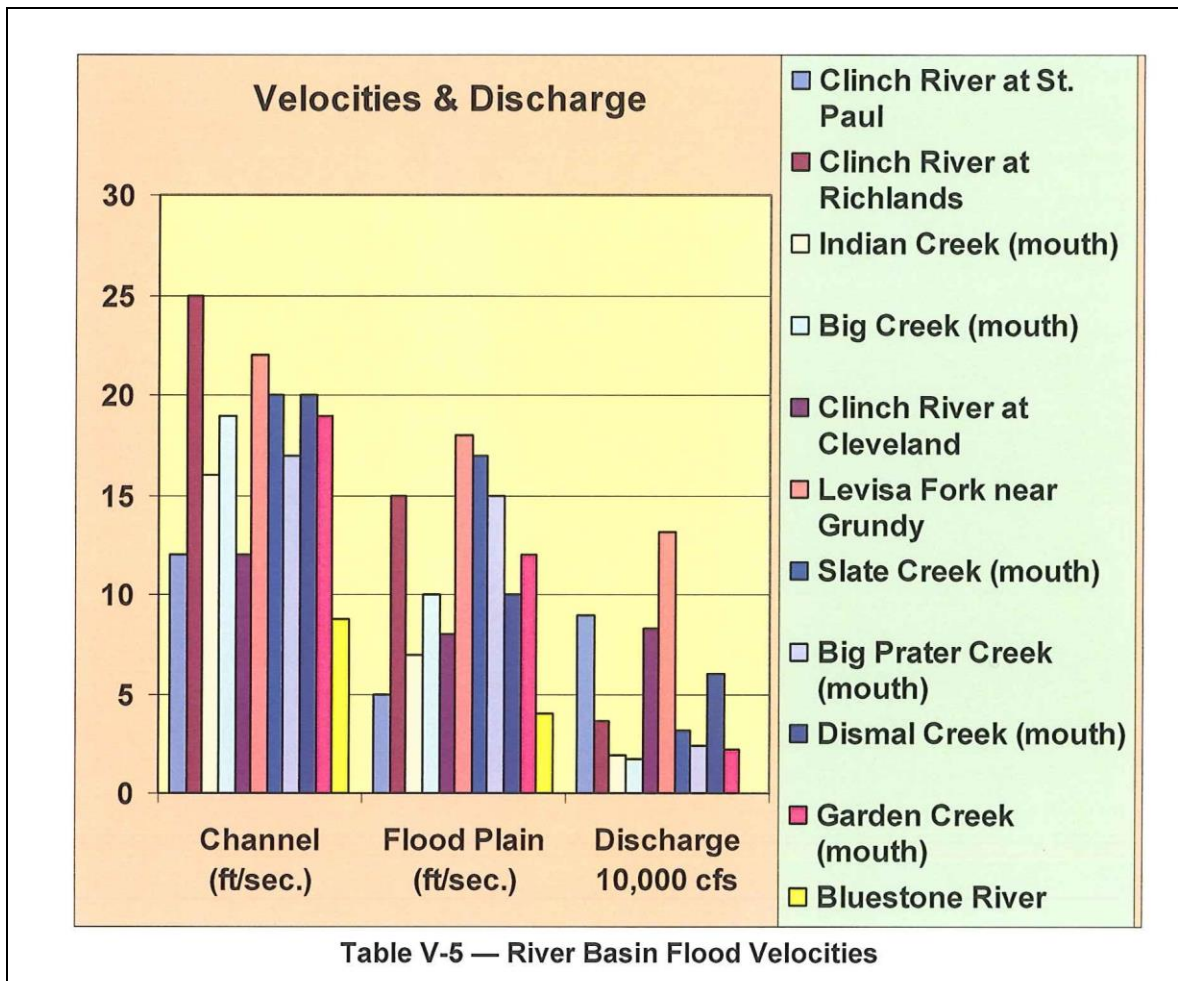
significant scour around structures and roadways (FEMA 259). The relatively high velocity of floodwaters in the area will increase damages throughout the Planning District. Flood velocities in Figure V-5 are based on the Maximum Probable Flood.

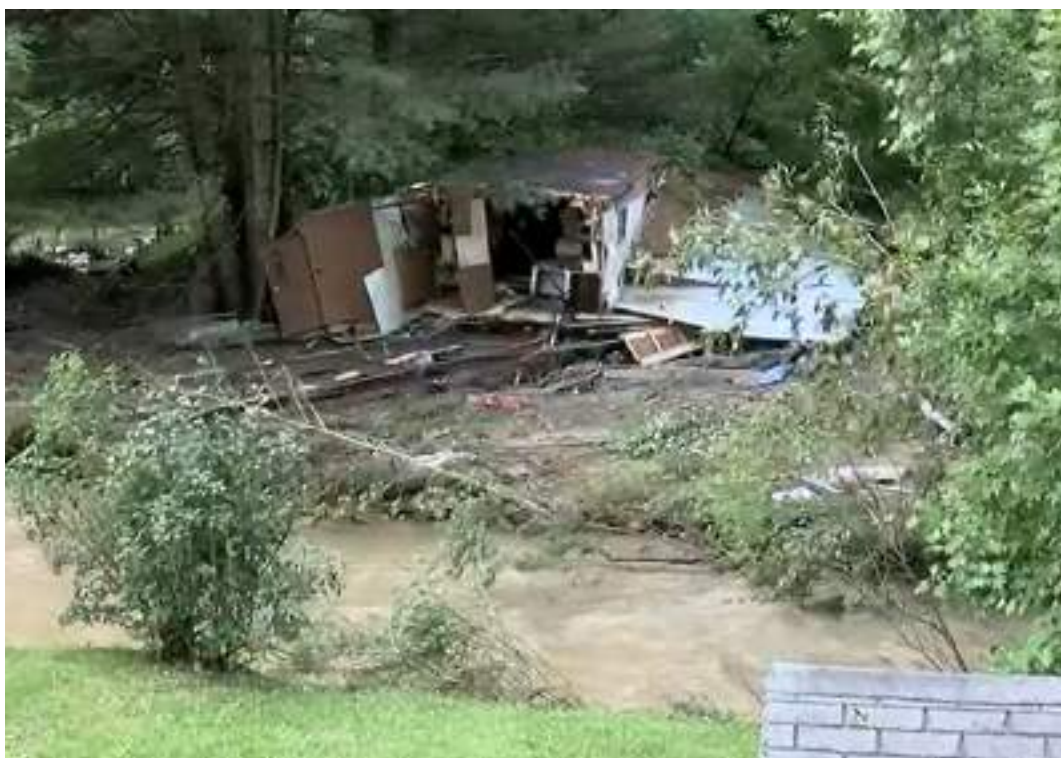
*Figure 644: Mobile Home that was Destroyed during the July 2022 Flood Event in Bandy, VA<sup>51</sup>*

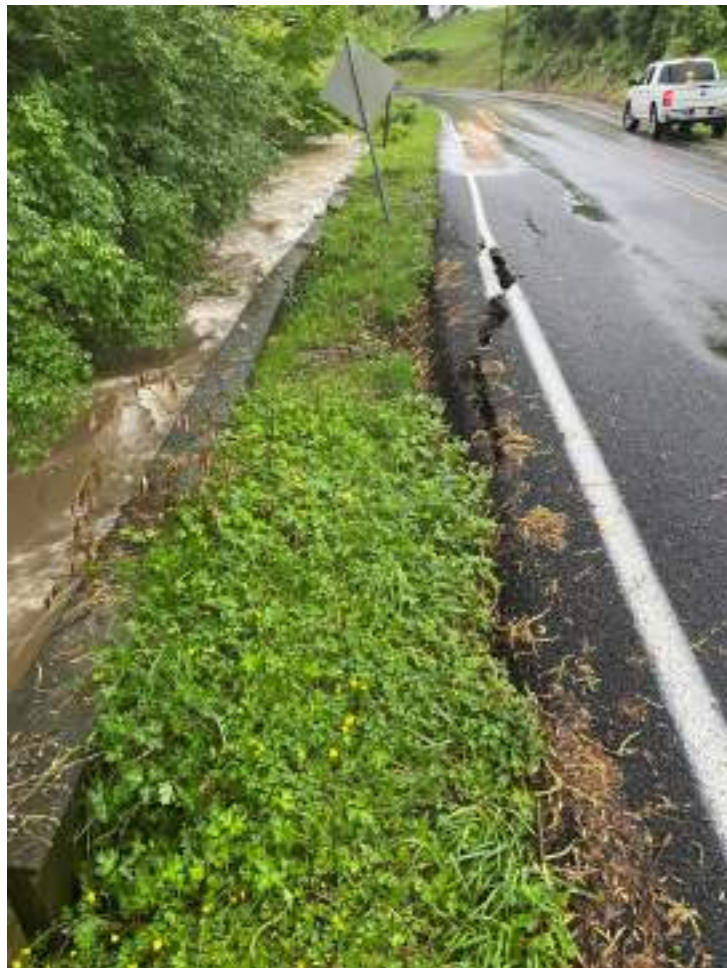
Figure 645: Road Damage in Bluefield, VA from Flooding in March 2023

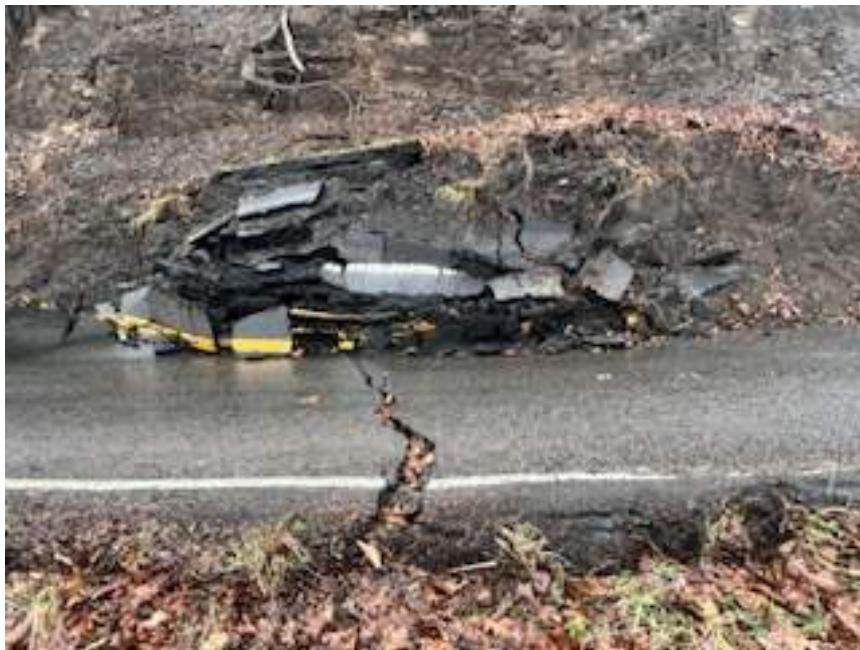
*Figure 647: Damage from Landslide Event on Route 91*

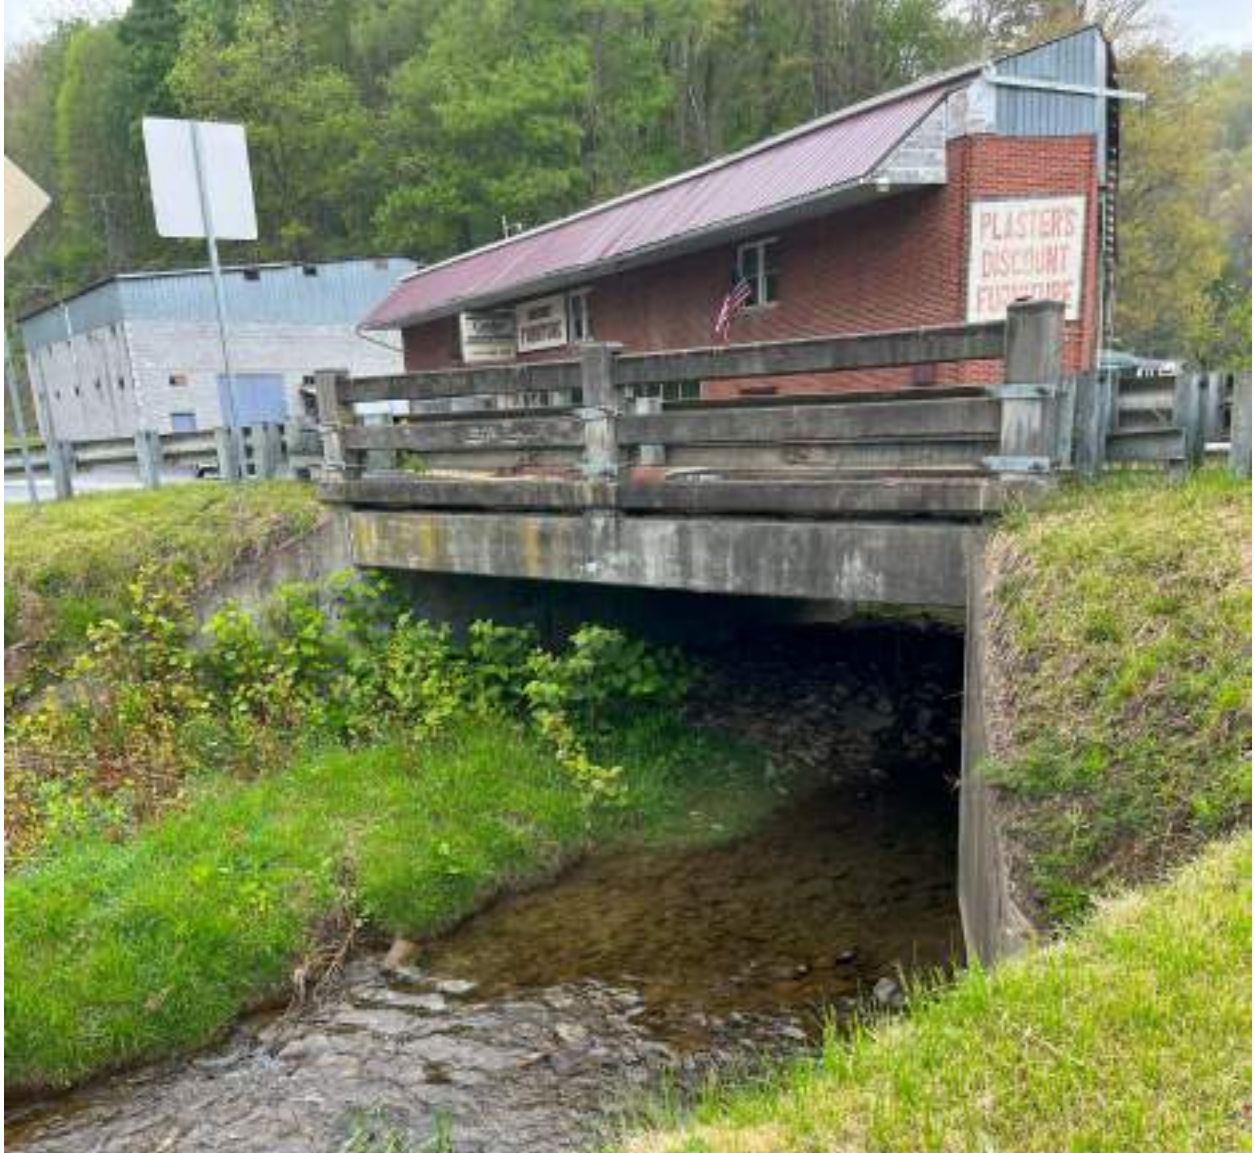
*Figure 727: Culvert crossing Mill Creek*
